# TOWER ACCESS STAIRS

CASE STUDY

A 9-story industrial tower processing corrosive chemistries required primary stairs, edge protection, floor grating, and mechanical access platforms. Galvanized steel solutions were heavy and inflexible, introducing safety and coordination challenges as well as high cost of construction in tight quarters.

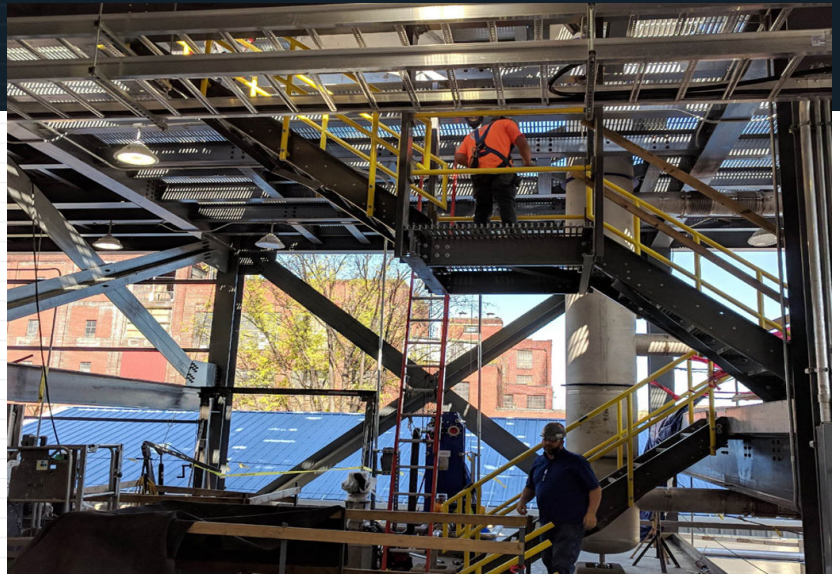
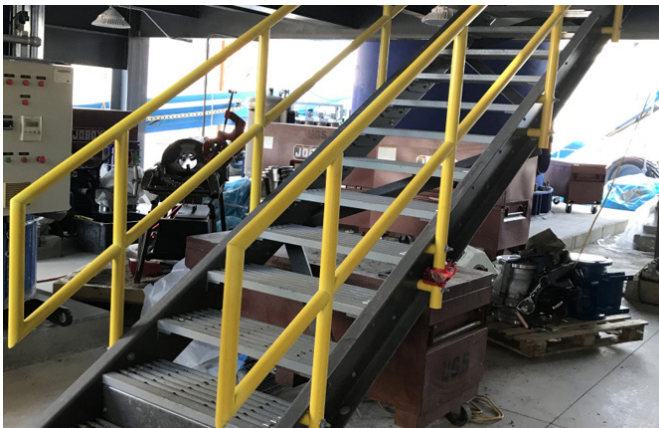
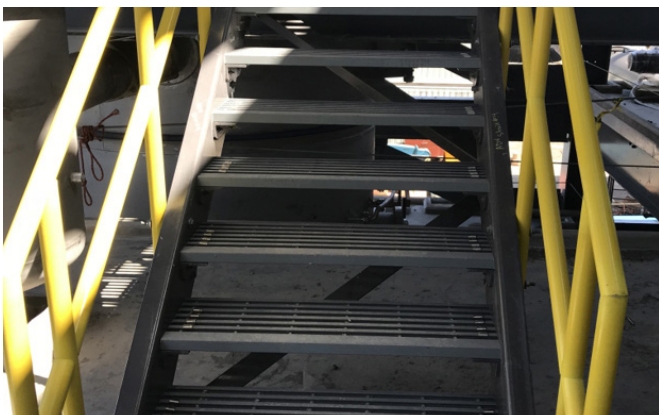
Advantic structural engineers utilized fiber-reinforced polymer structural profiles to meet Code-prescribed strength and serviceability criteria. Connection details were coordinated with the steel elements for integrated design and delivery. Project Managers facilitated BIM coordination with the mechanical trades to ensure seamless installation.

Structural system dead load was reduced by 63-percent, reducing foundation and seismic lateral system costs. Fabrication lead times were reduced by 50%. Crane time was eliminated from installation, and FRP grating was installed at least 2x faster than steel. Little future maintenance will be required.
